# UPPER GILA RIVER FLUVIAL GEOMORPHOLOGY STUDY

## FINAL REPORT RECOMMENDATIONS FOR DEMONSTRATION PROJECTS NEW MEXICO

US Department of the Interior  
Bureau of Reclamation

MARCH 24, 2004

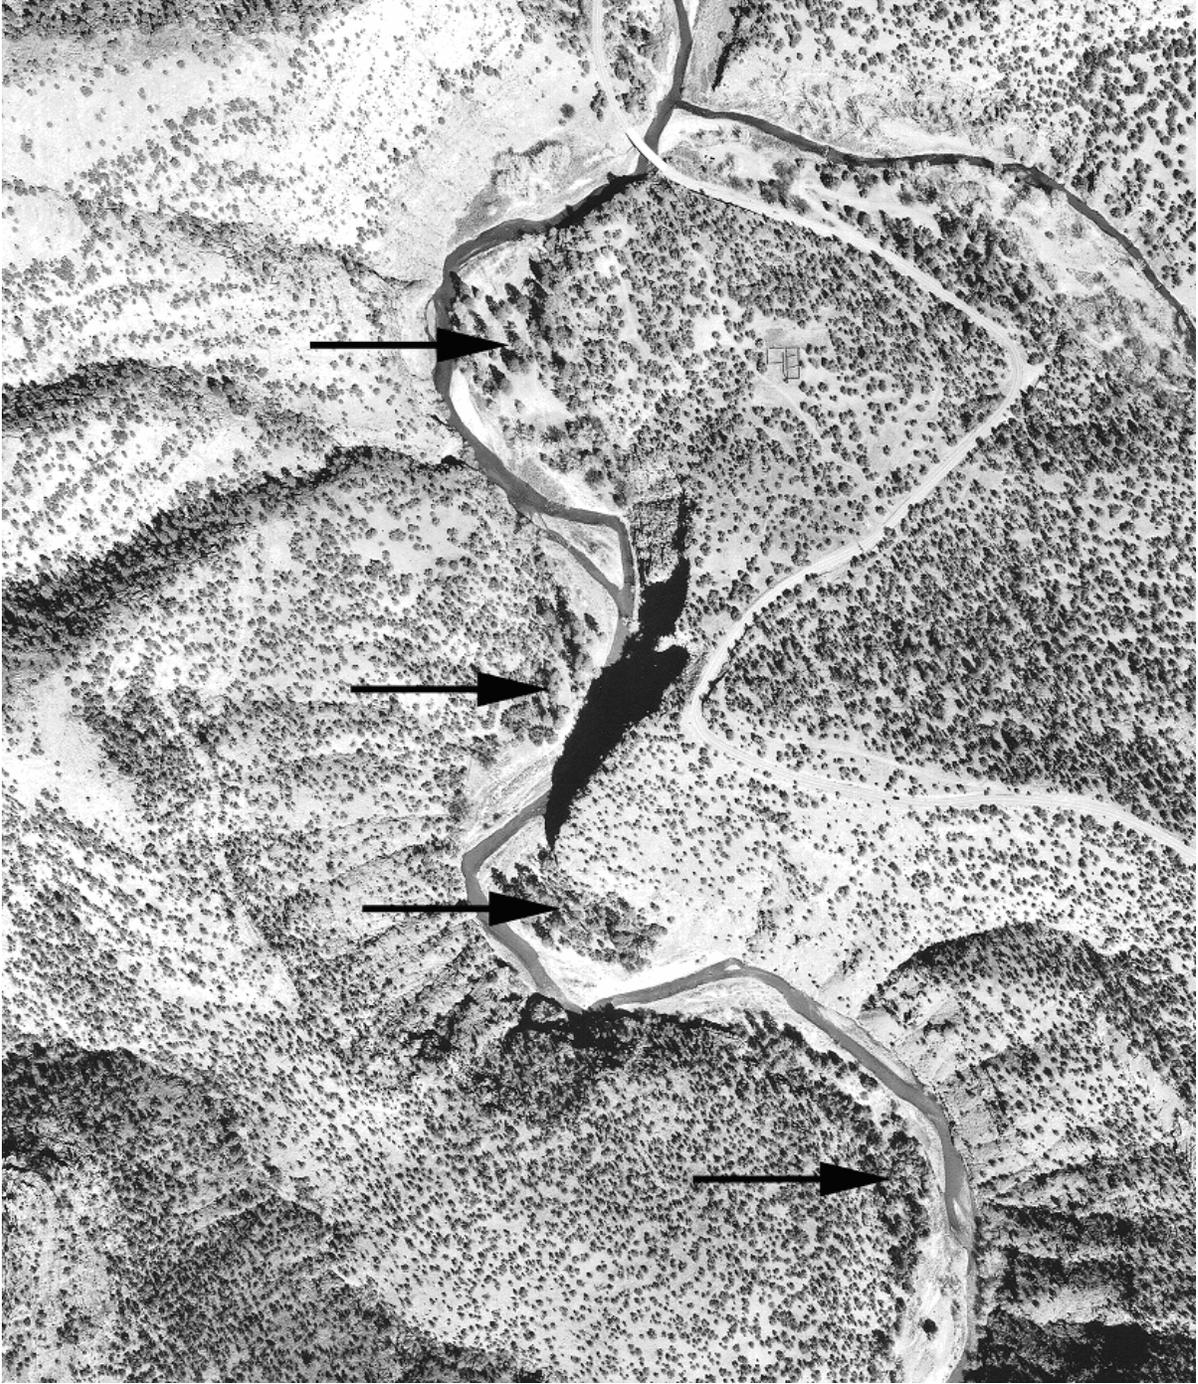
Field reconnaissance for this study indicates a clear record of stability of geomorphic surfaces that bound the Gila River in the Upper Box. The record of stability predates 19th and 20th century changes in land use or management. Figure 2 shows several areas in the Upper Box with this record. A key observation from the field reconnaissance is the numerous old sycamore and pine trees rooted at an elevation near that of the current flood channel. Figure 3, Figure 4, and Figure 5 picture several of these trees. Although no specific information about the age of these trees was developed as part of this task, the larger, longer-living species appear to predate the advent of grazing and fire suppression in the 19th and 20th centuries. The observations from this limited reconnaissance study indicate that the bed elevation of the Gila River in the Upper Box has been dynamically stable for the last several centuries. Further supporting this conclusion are the truncated alluvial fans at the mouths of many tributaries. The truncated fans are at a height commensurate with the stage of the largest historical floods on the Gila River. This relationship should not be present if there had been a recent, major change in the bed elevation of the Gila River.

*Figure 2- Aerial photograph of the upstream end of the Upper Box of the Gila River. Arrows indicate areas of stable alluvium characterized by stands of larger juniper, cottonwood, walnut, and pine trees.*

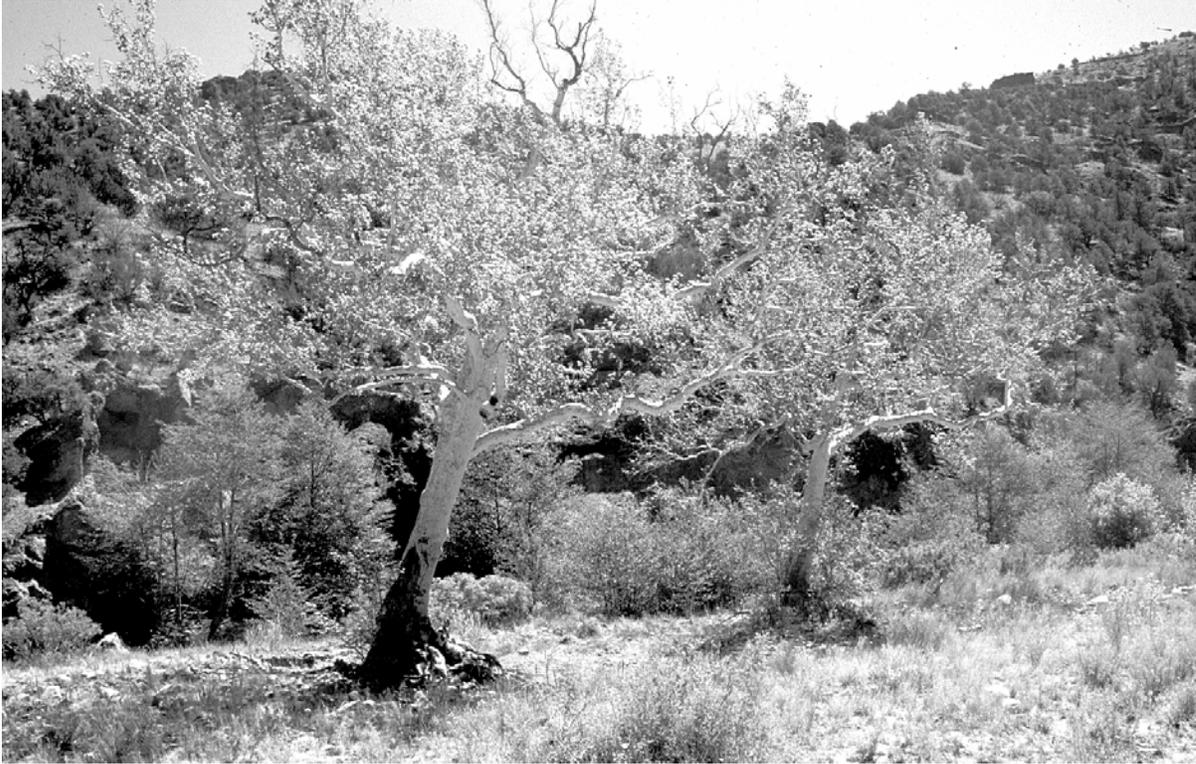
*Figure 5 – Sycamore trees growing in the active flood channel of the Gila River near the upstream end of the Upper Box of the Gila River. The trees are rooted at an elevation similar to that of the current active channel.*

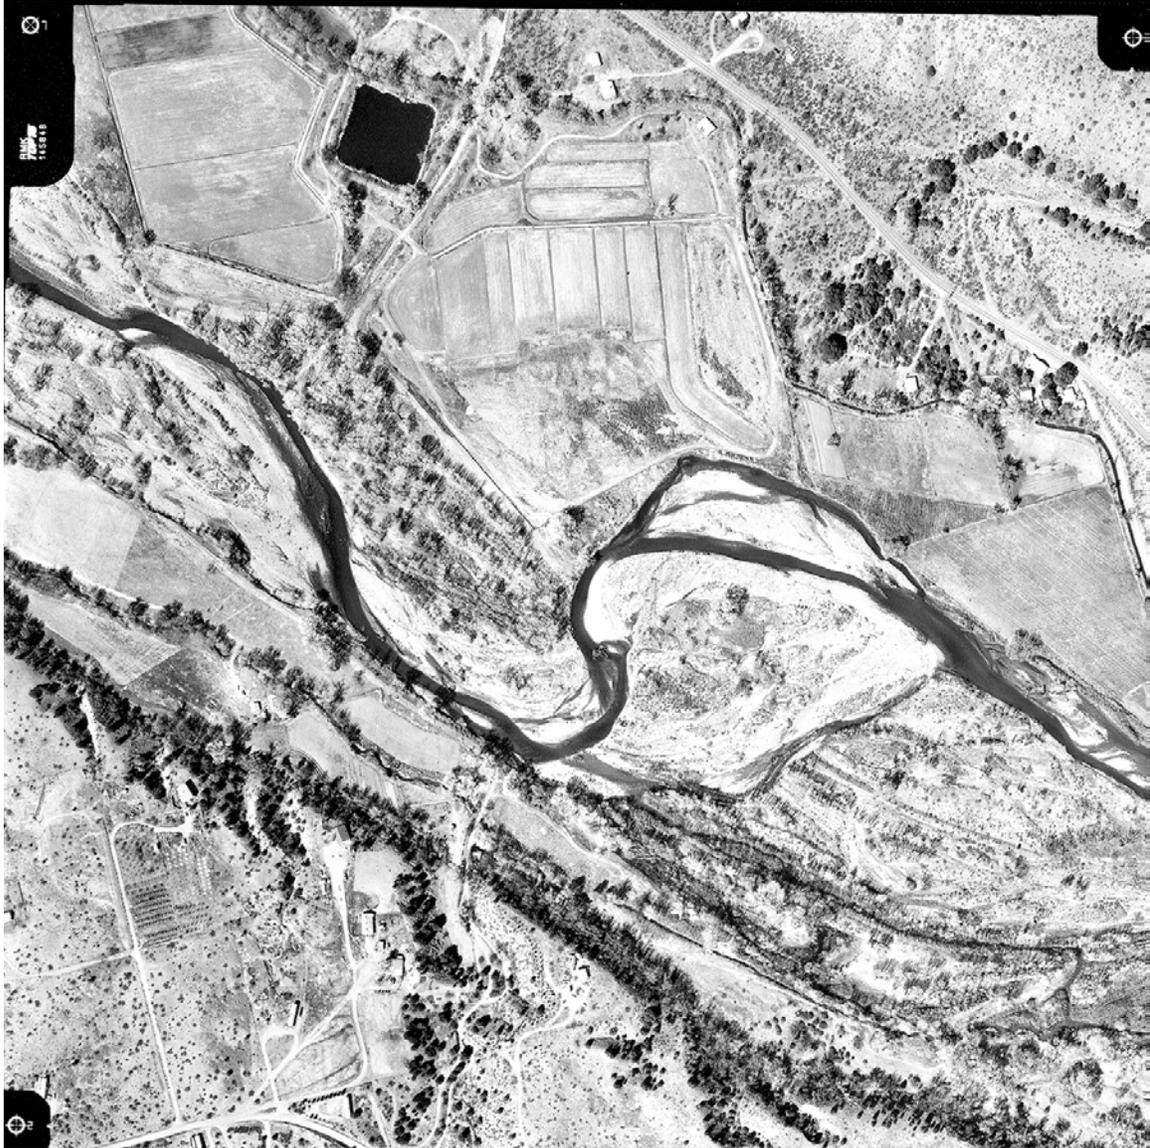
Levees constructed on the Gila River lead to property loss in several ways. First, when the levees fail during floods, the flow tends to exit through the levee failure nearly perpendicular to the normal flow direction of the river. This results in erosive, high-energy flows at right angles to the pre-existing bank. Since the banks of the Gila River are formed of vertically accreted flood sediment, these high-energy flows rapidly erode the former banks. Once outside the levees the water flows down the valley slope eventually leading to a failure from the outside of the levee so the floodwater can return to the channel. This results in a diagnostic asymmetrical downstream bend (Figure 19 and Figure 20). These exaggerated bends or meanders can propagate downstream. At the downstream end of these exaggerated bends, the flow is nearly perpendicular to the normal flood channel and aimed at the opposite bank. This may result in levee failure or bank erosion on the bank opposite the exaggerated bend. This in turn causes an exaggerated bend or meander in the new location by the same process. This process can continue downstream until flood discharge decreases or some restraining feature is encountered.

*Figure 19. Asymmetrical downstream-exaggerated meander typical of erosion resulting from levee failure. Enlargement March 4, 2001 aerial photograph in the vicinity of the Seeds of Change Farm.*

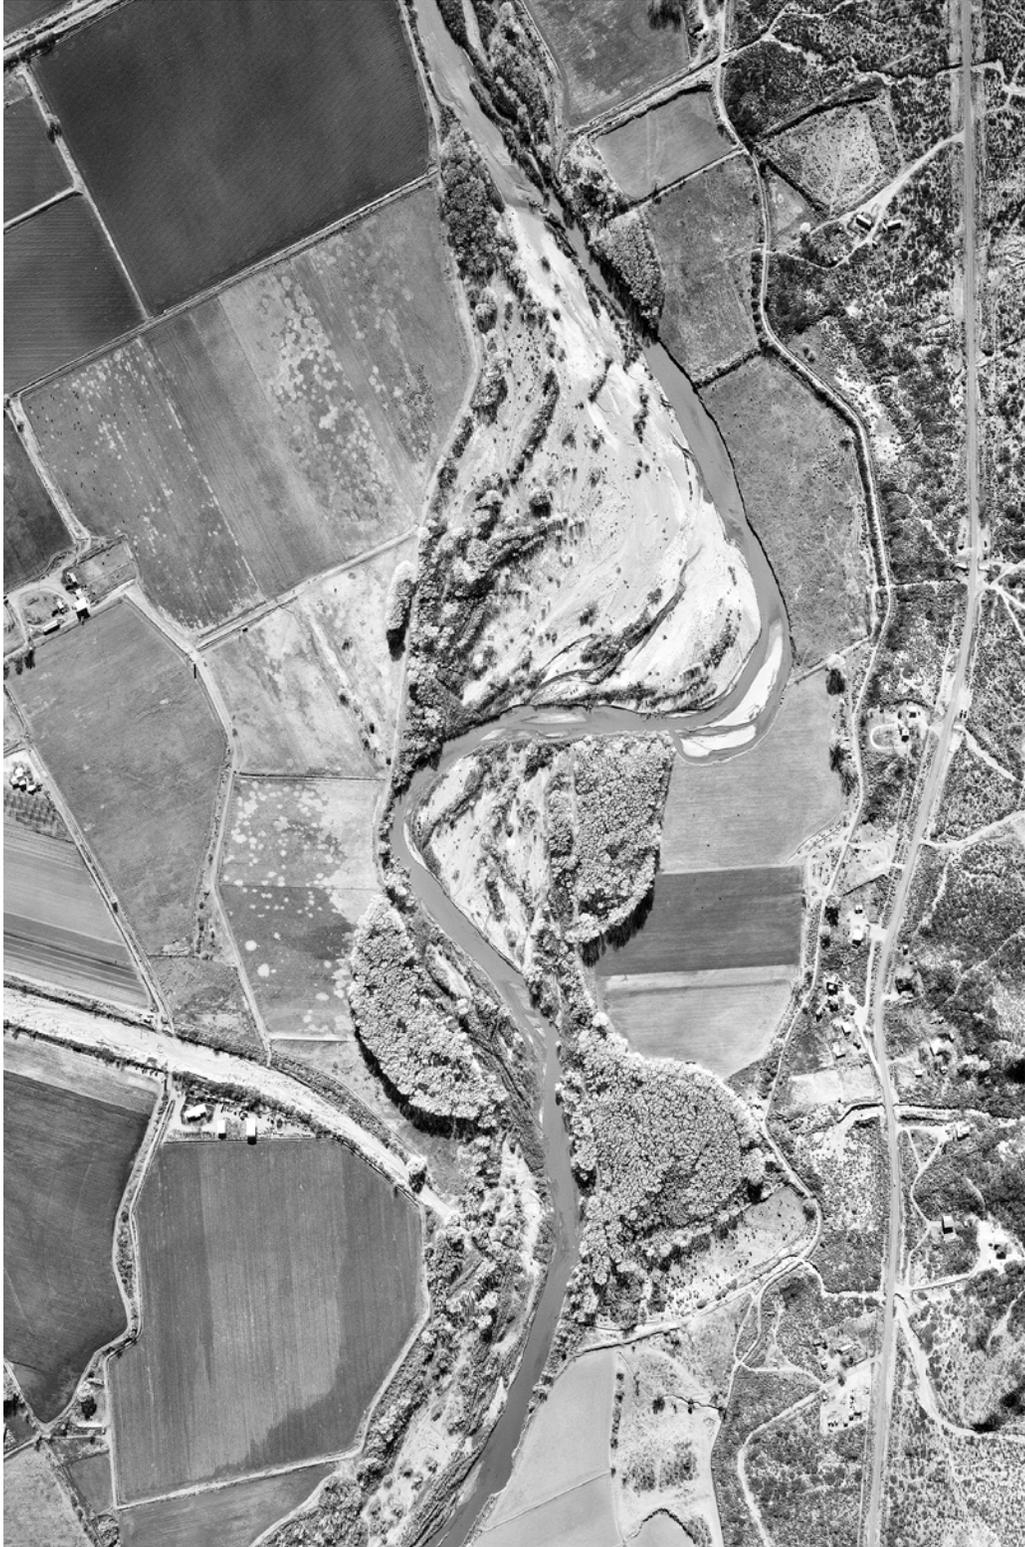
*Figure 20. Asymmetrical, exaggerated meander south of Virden near the mouth of Windham Canyon. This meander is the result of levee construction and subsequent failure resulting in substantial property loss. See the Geomorphic Map Location 23 for comparison.*

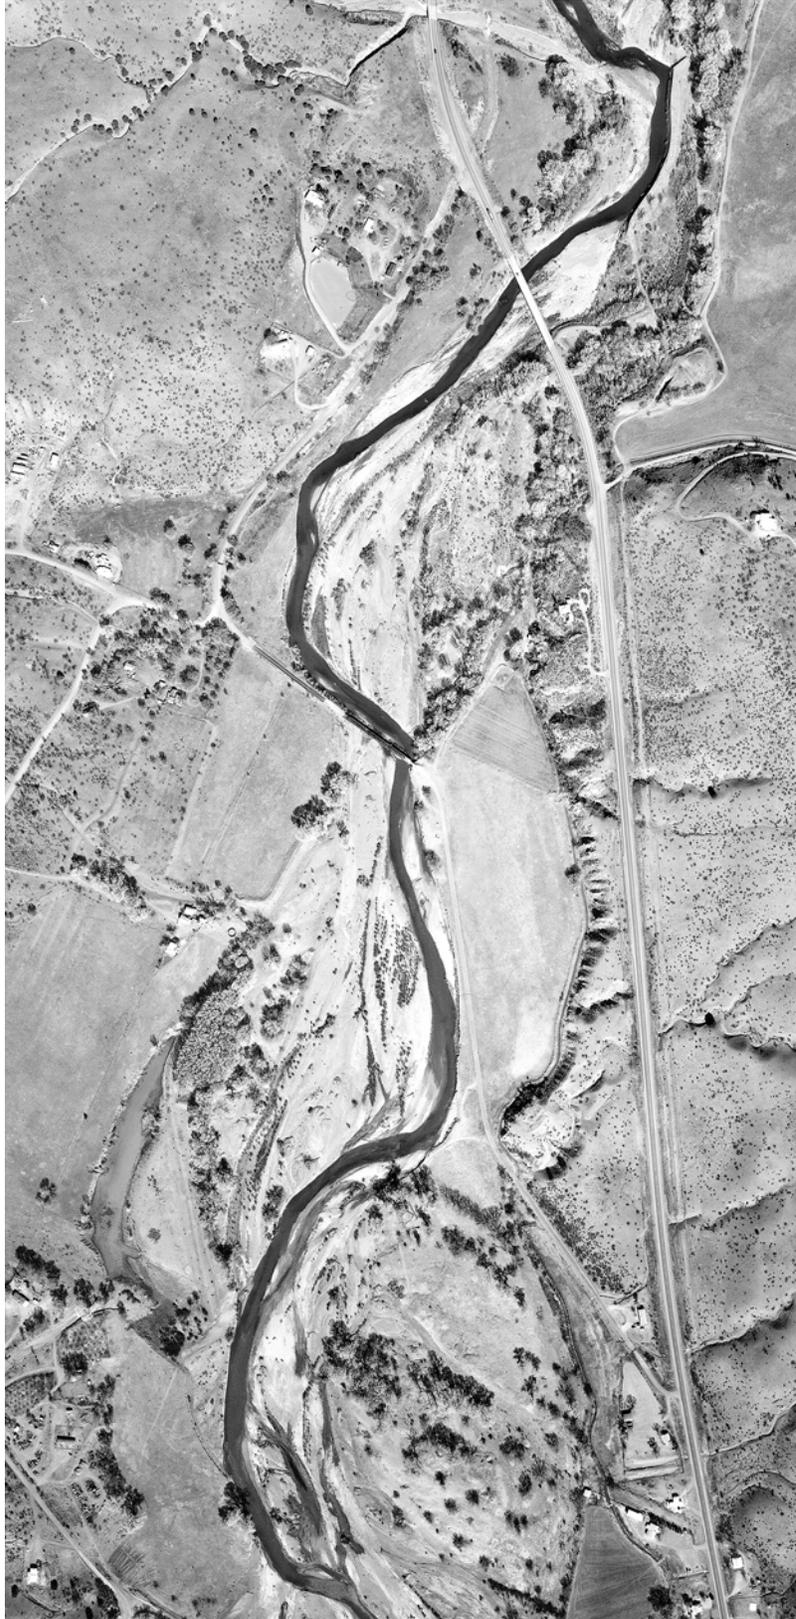
*Figure 21. Flow under the Highway 180 Bridge (top) apparently helped cause erosion upstream of the Iron Bridge. To slow this erosion a levee was constructed upstream of the Iron Bridge redirecting flow downstream resulting in considerable erosion. Compare with Locations 11-15 on the Geomorphic Map.*

Property loss in the area of Riverside downstream of the Iron Bridge is likely the result of flow redirection by a levee constructed just upstream of the Iron Bridge. It is possible that this levee was constructed in response to flow redirection caused by the Highway 180 Bridge. The construction of this levee upstream of the Iron Bridge resulted in redirection of flow and nearly out of phase meandering of the Gila River in the valley near Riverside. This is documented by flow of the Gila River that is now nearly perpendicular to the former banks.

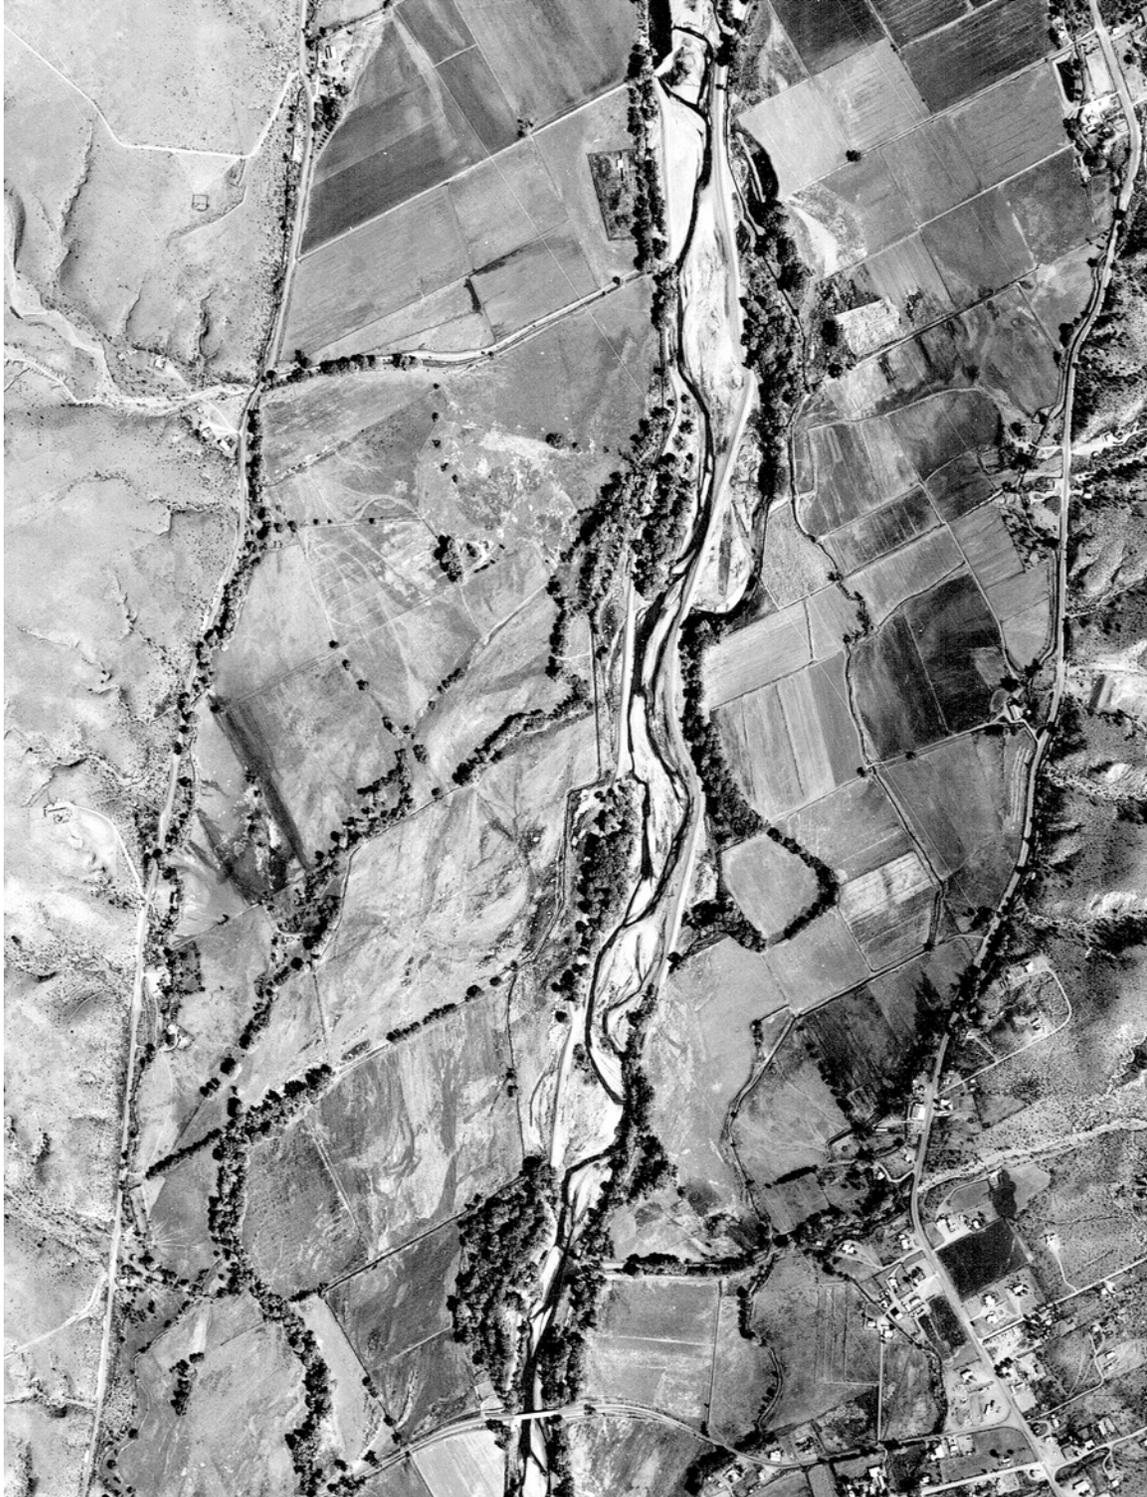
*Figure 22. Levees upstream of the Highway 211 Bridge visible on 1980 aerial photographs. The distance between the levees is irregular and in places the levees are not parallel to each other. The levees are also constructed oblique to the flood channel that will lead to eventual levee failure.*

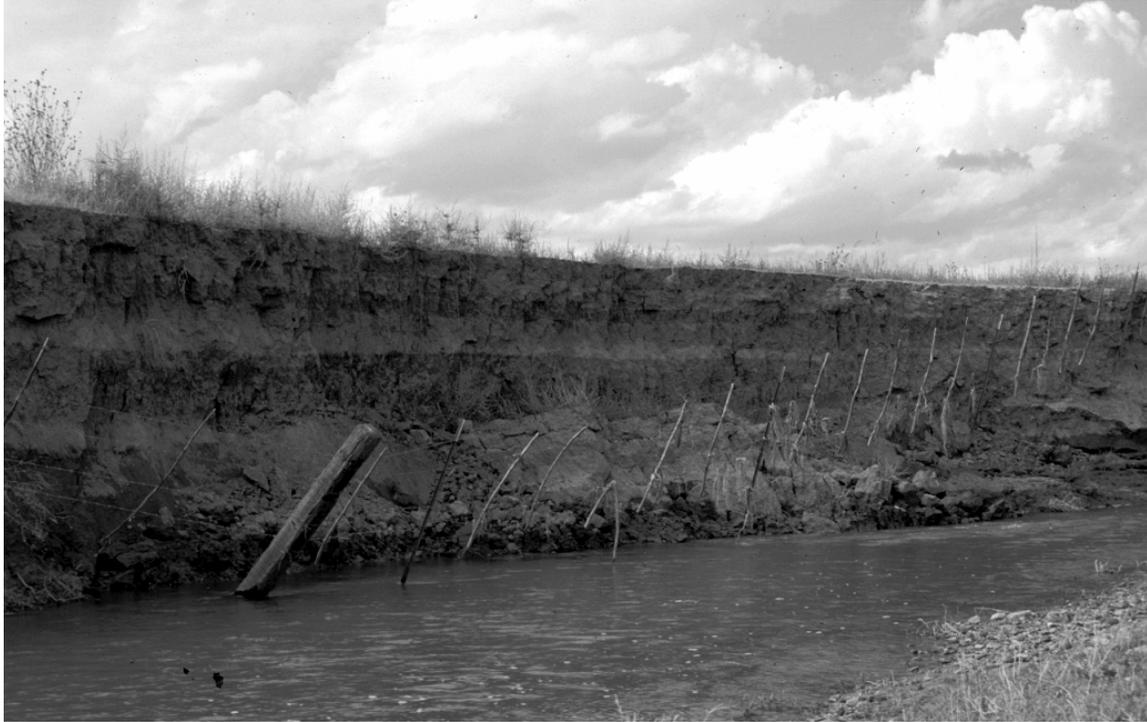
*Figure 23. Another eroded bank in the Virden Valley that resulted from levee failure. The bank is composed of vertically accreted flood plain sediment and is likely more than several thousand years old.*
